**BUZZARDS BAY
RAILROAD LIFT BRIDGE
OVER CAPE COD CANAL**

INSPECTION AND CONDITION REPORT

OCTOBER, 1984

MODJESKI AND MASTERS

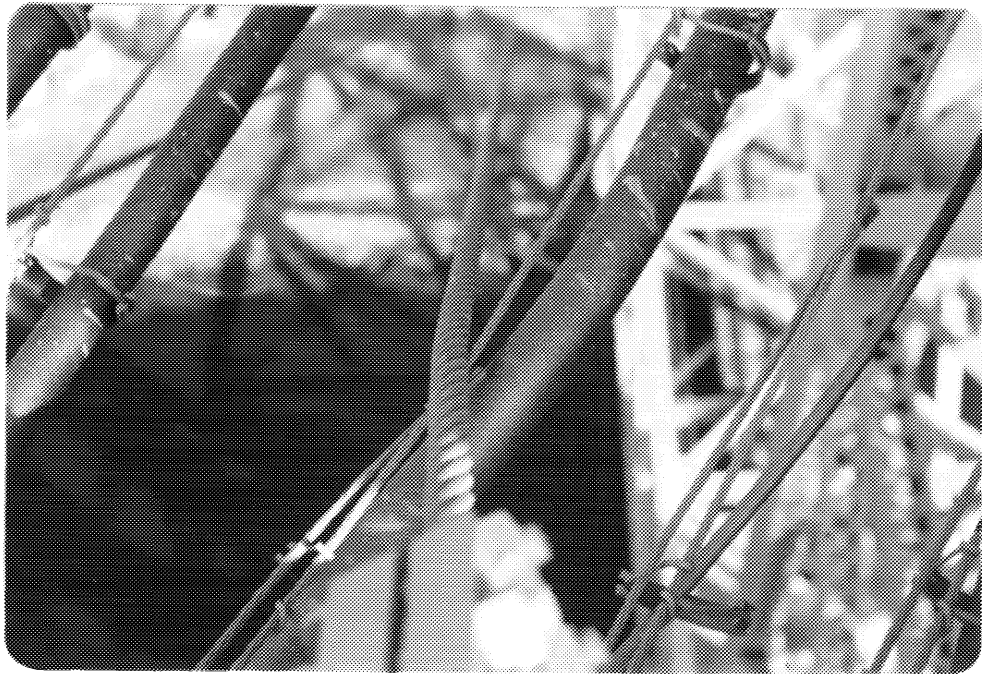
Photograph I-31 - Contact between inboard backstay cable and secondary messenger at northwest cantilever bracket.

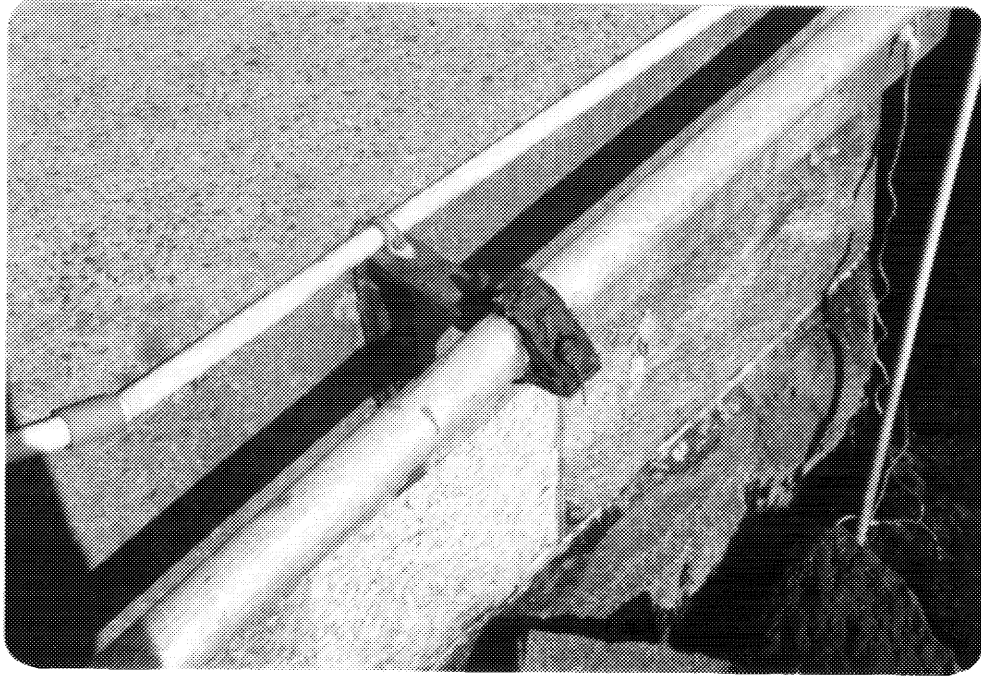
Photograph I-32 - Broken plastic conduit and corroded support clamp on Abutment D.

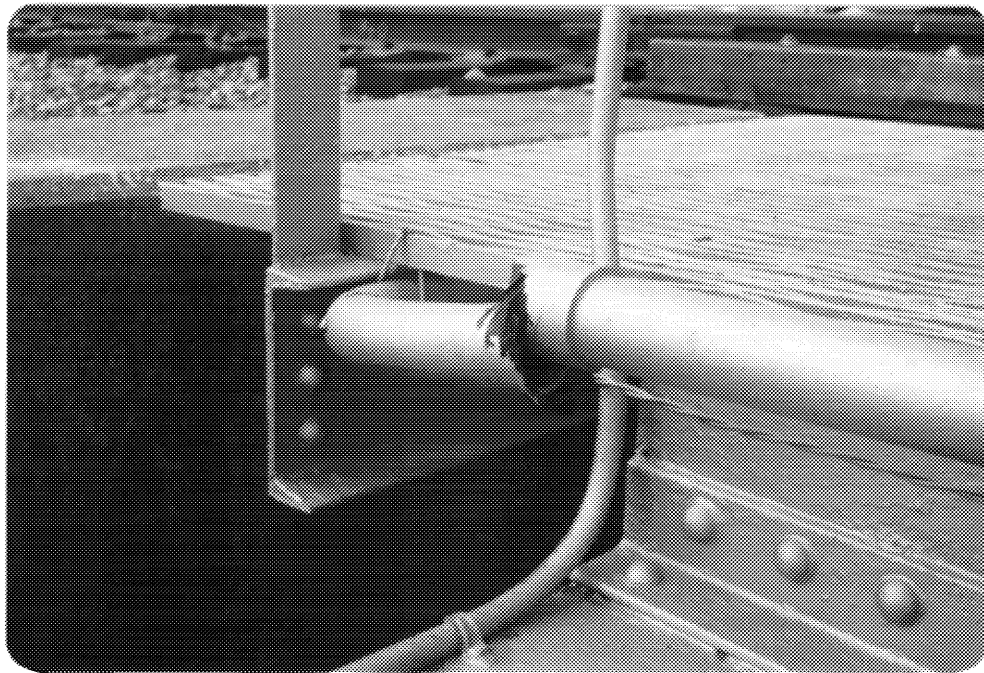
Photograph I-33 - Broken and improperly supported plastic conduit on south tower span.

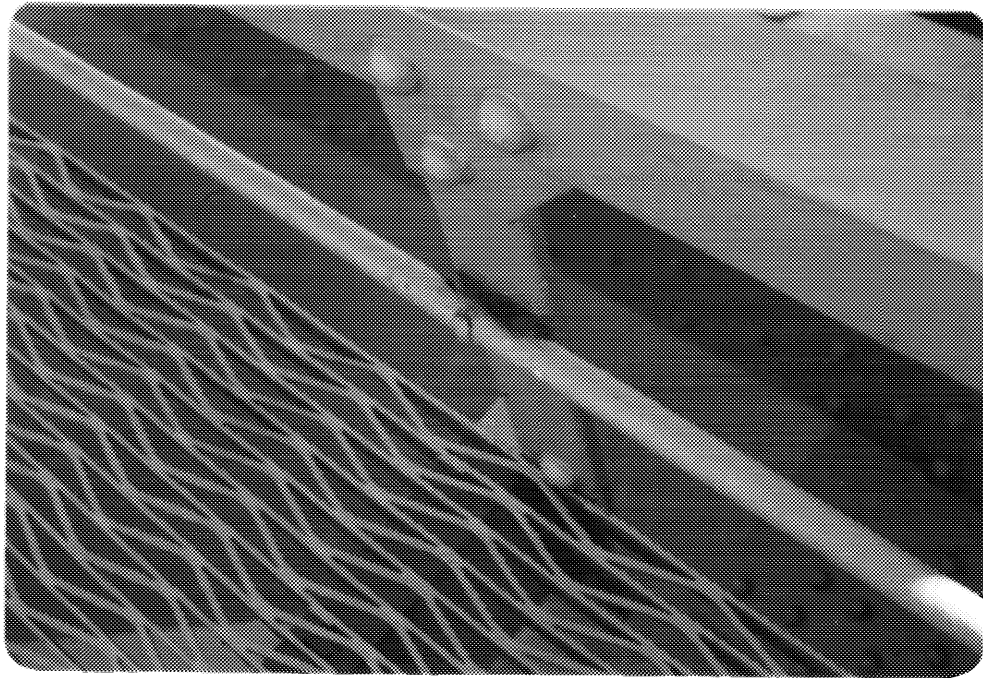
Photograph I-34 - Corroded conduit along the lift span walkway.

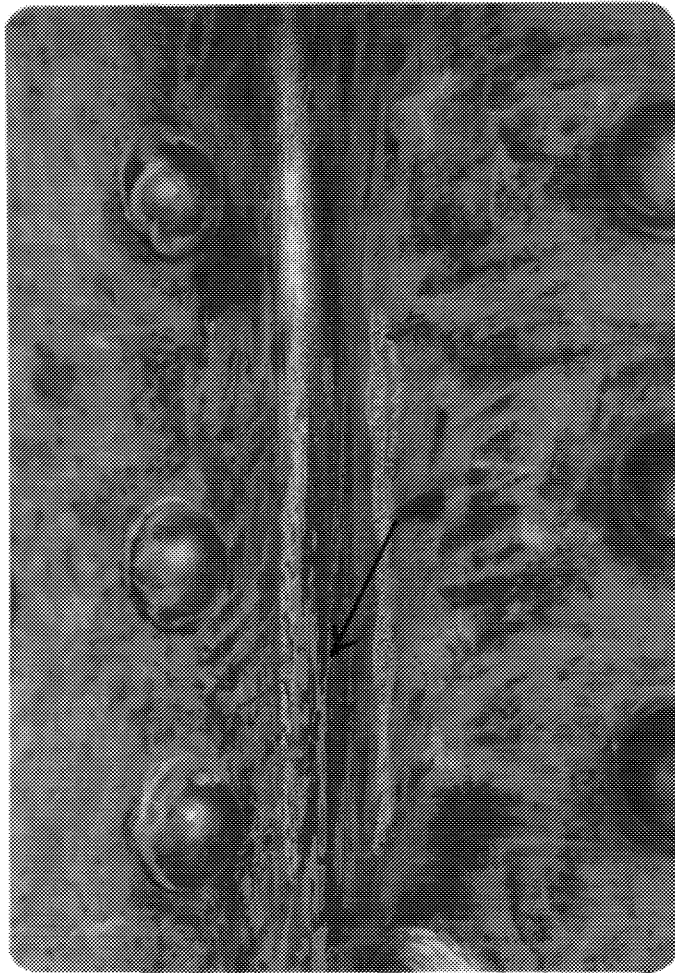
Photograph I-35 - Minor
imperfection in fillet of
west stringer connection
angle at Panel Point 4,
south approach span.

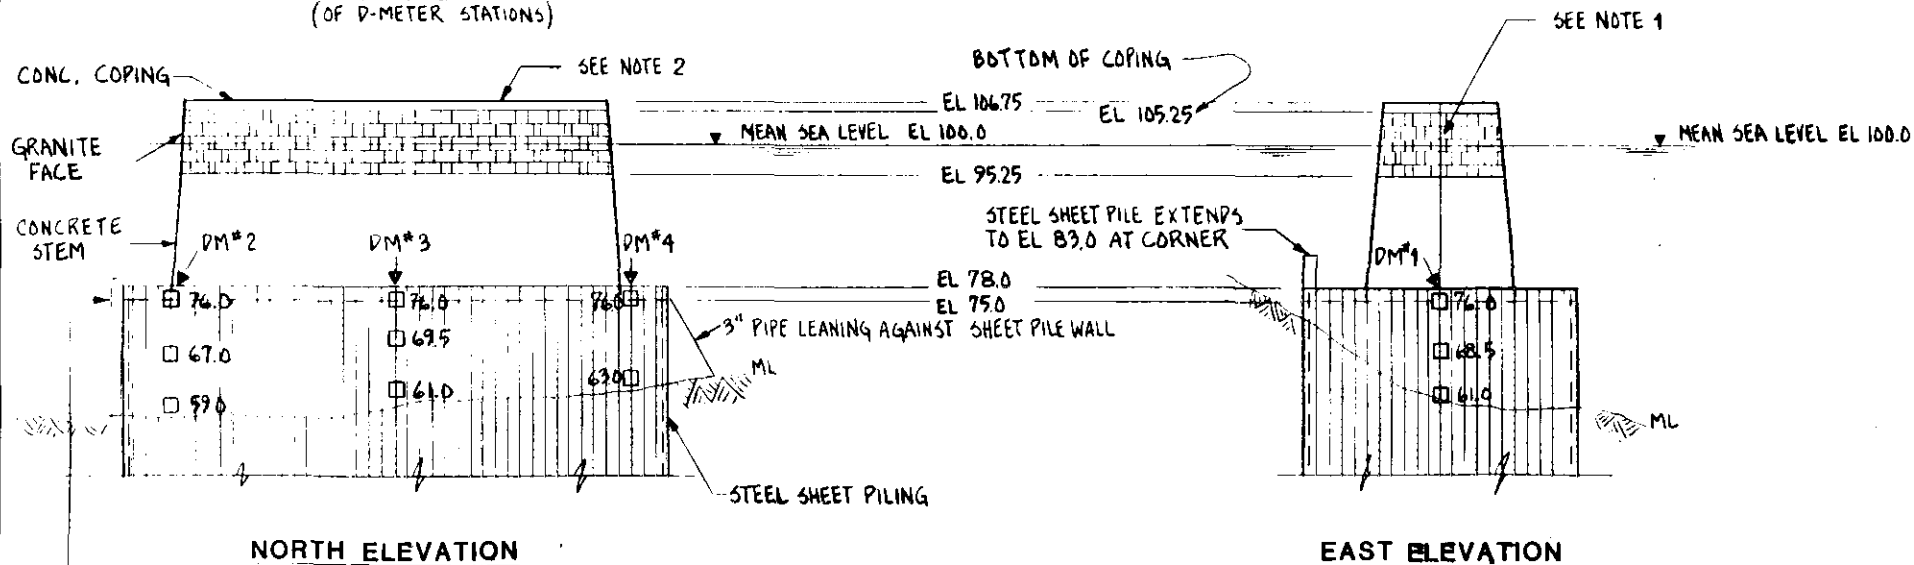
Near the northeast corner of the Pier B cofferdam and the northwest corner of the Pier C cofferdam, the sheet pile wall appears to have been damaged by impact. Sections of sheet pile are bent over the top of the concrete base at Elevation 75 at both locations. Local crushing of the concrete base exists at these areas; however, no repairs are required.

LOCATION OF IMPACT DAMAGE TO SHEET PILES
SEE FIG 597-84-3 FOR DETAIL
